## Cost-effective Enhancement of Durability of Concrete Structures by Intelligent Use of Stainless Steel Reinforcement

Knudsen, A. <sup>(1)</sup>, Jensen, F.M. <sup>(1)</sup>, Klinghoffer, O. <sup>(2)</sup> & Skovsgaard, T. <sup>(3)</sup>

### ABSTRACT

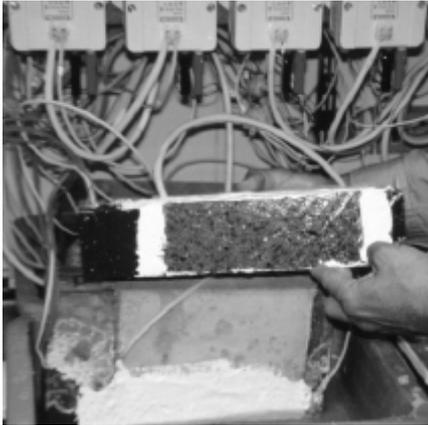
**Figure 4** Experimental setup for group 1 and group 2.

**Group 1:** Three concrete samples, each containing five carbon steel rebars and two short (6 mm (~1/4 in.)) stainless steel rebars corresponding to 5% and 10% of the total volume of the steel in the sample. The stainless steel rebars are closest to the concrete surface, which will be exposed to the aggressive environment. The carbon steel rebars are located behind the stainless steel, at different but defined depths from the exposed concrete surface.

Figure 2 and Figure 3 show the above-described samples and the principle of measurements. Figure 4 and Figure 5 show photos of the test setup.

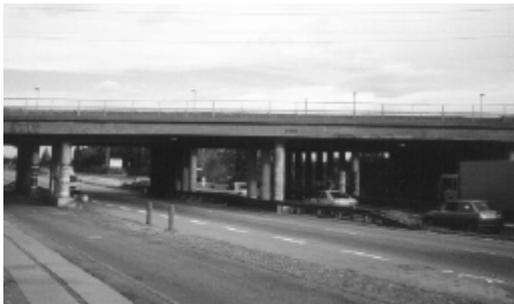
**Figure 8** Example a) : Typical highway RC columns requiring repair or replacement after 20-30 years.

In this example a 30-year old bridge with several (18) slender columns (see example in Figure 8) with serious corrosion on the reinforcement on the lower 2 m (~7 ft.) of each column is considered. The extensive corrosion requires at least a 50% replacement of the reinforcement at the lower 2 m. The amount of reinforcement to be replaced is 10% of the total reinforcement steel in the column and foundation. Several repairs similar to the one described have previously been carried out in Denmark using carbon steel.

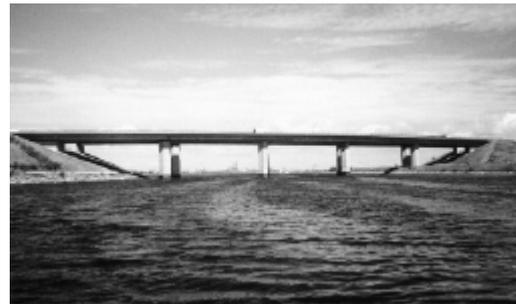
**Figure 9** Example b) : Typical Danish coastal RC columns which may require repair after 20-40 years.

An ongoing research project financed by the Danish Road Directorate, [19], has shown that some fairly new coastal bridges need repair in the splash zone due to chloride-induced corrosion, see example of a coastal bridge in Figure 9.
